## A Method to Quantify Road Safety Audit Data and Results

A METHOD TO QUANTIFY ROAD SAFETY AUDIT DATA AND RESULTS

A thesis submitted in partial fulfillment  
of the requirements for the degree

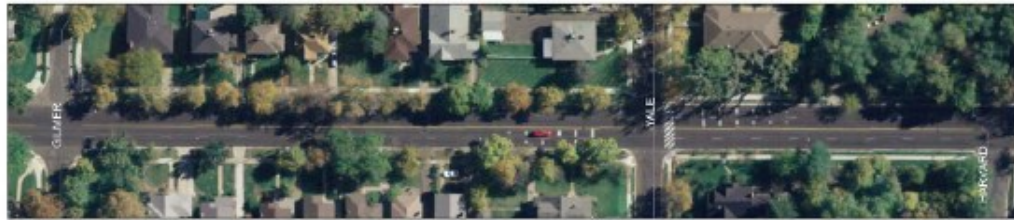
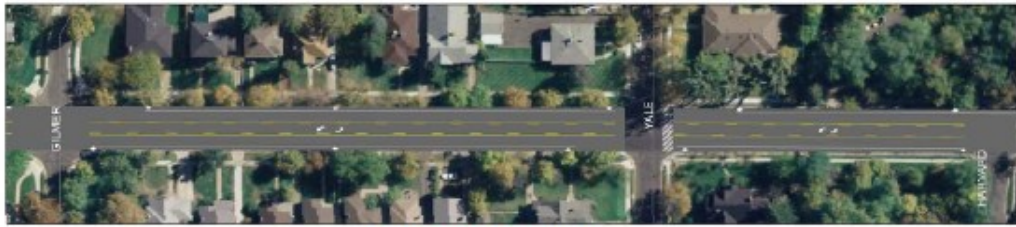
Existing Striping

Proposed Striping

**Figure 3.3** Use of the Road Diet Concept to Add Bike Lanes and Remove Parked Vehicle Obstacles (SLC Transportation 2010).

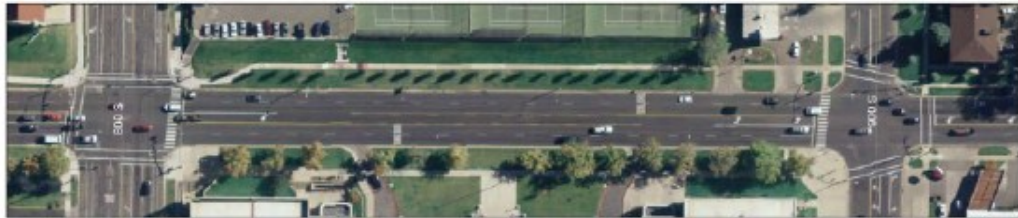
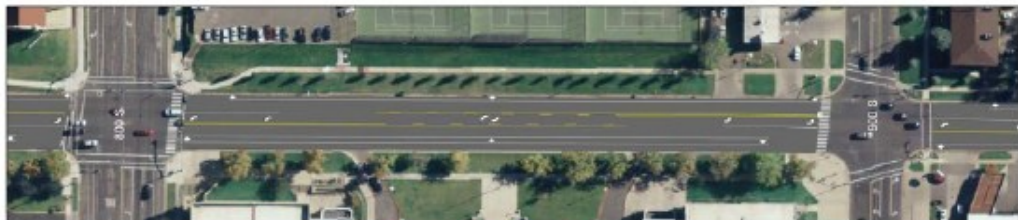
Existing Striping

Proposed Striping

**Figure 3.4** The Road Diet Concept That Allows for Parking on One Side of the Road (SLC Transportation 2010).
